U.S. Department of Justice
Office of the Inspector General

REPORT OF INVESTIGATION

| Federal Prison Industries, et al. Government Enterprise Beaumont, Texas | | [REDACTED] | |

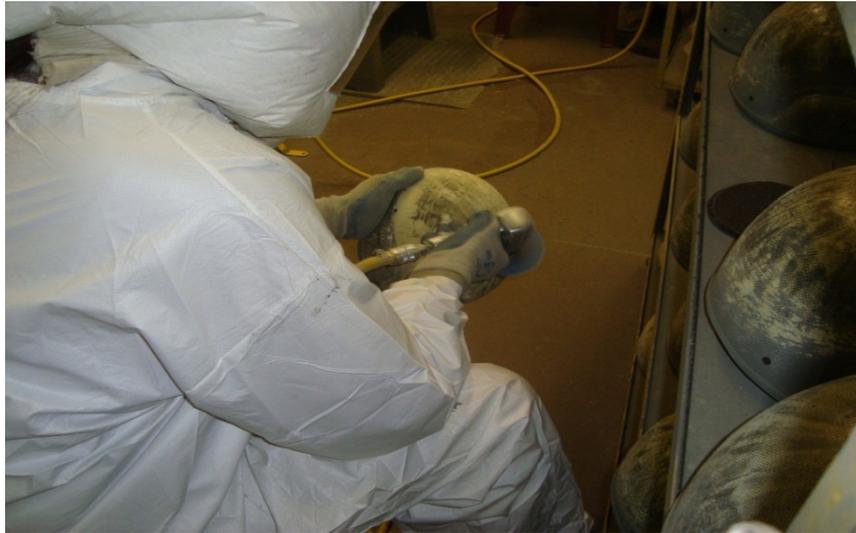
In 2009, the U.S. Army conducted random paint adhesion tests on certain helmet lots, which failed paint adhesion tests. The U.S. Army subsequently authorized the rework of these helmet lots so the helmets would conform to the contract specifications. After a September 2009 meeting with U.S. Army Quality Assurance Specialists, the FPI and ArmorSource intentionally disregarded agreed upon rework instructions calling for the removal of paint by hand sanding and instead, used unauthorized improvised implements and power sanders to remove the paint, potentially impacting the ballistic integrity of the helmets.

Figure 3: Inmate using power sander to remove paint.

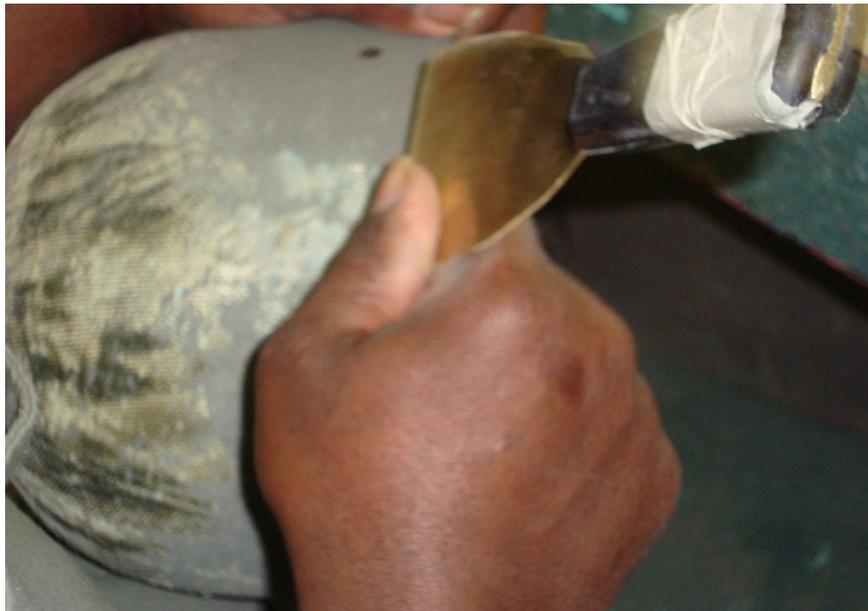
Figure 4: Inmate using putty knife to remove paint.

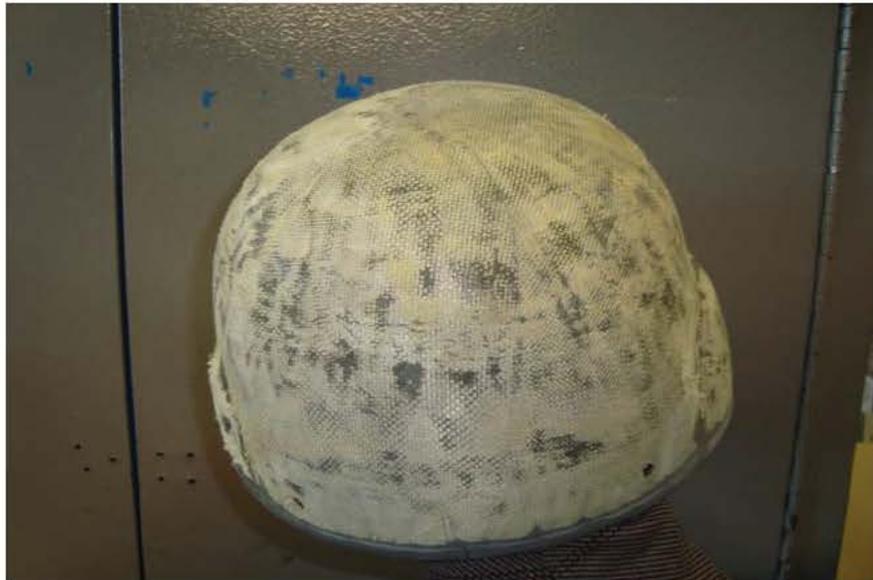
Figure 5: Damaged ACH after paint removal.

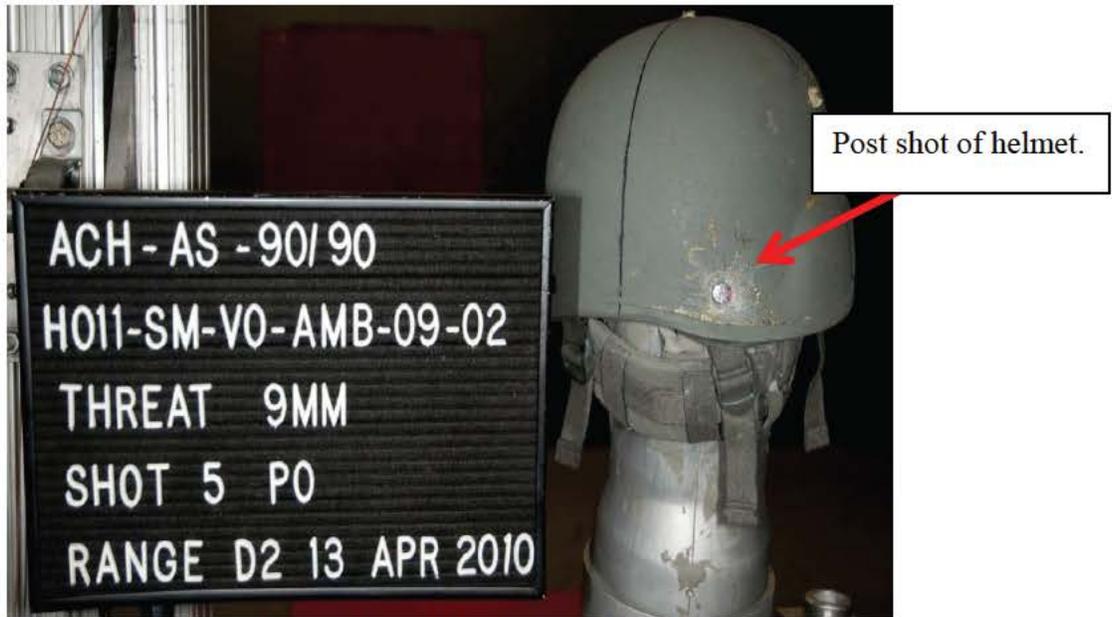
- lots 2, 68, 154, and 248 did not meet resistance to ballistic penetration specifications;
- lot 68 did not meet ballistic fragmentation test specifications; and
- lot 68 did not meet weight specifications.

Figure 6: Post shot of helmet on head form.

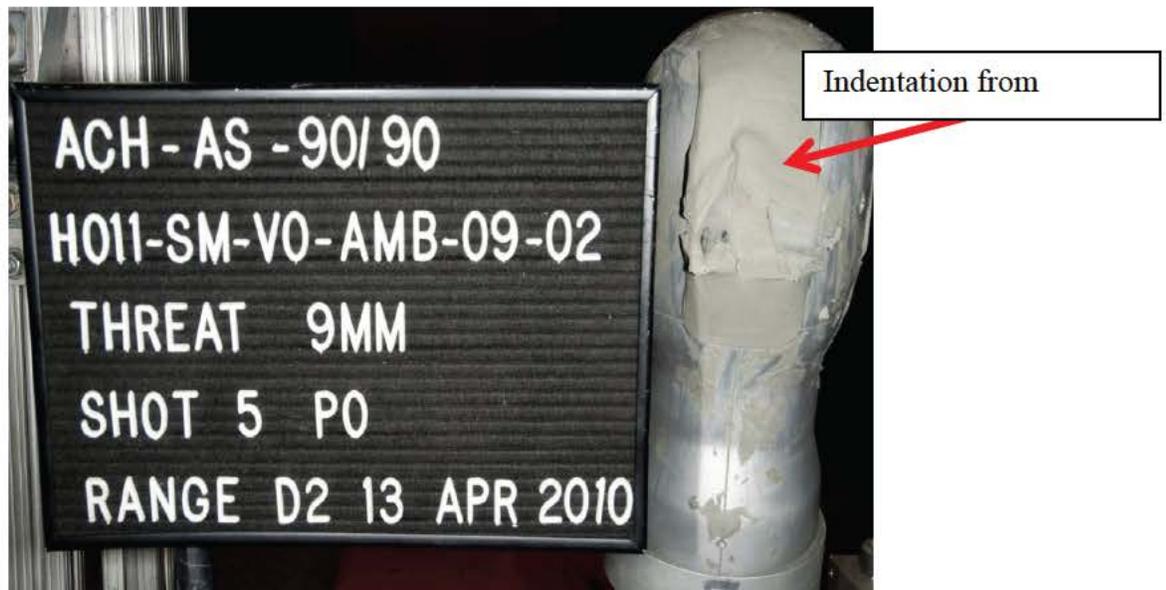
Figure 7: Post shot of head form.

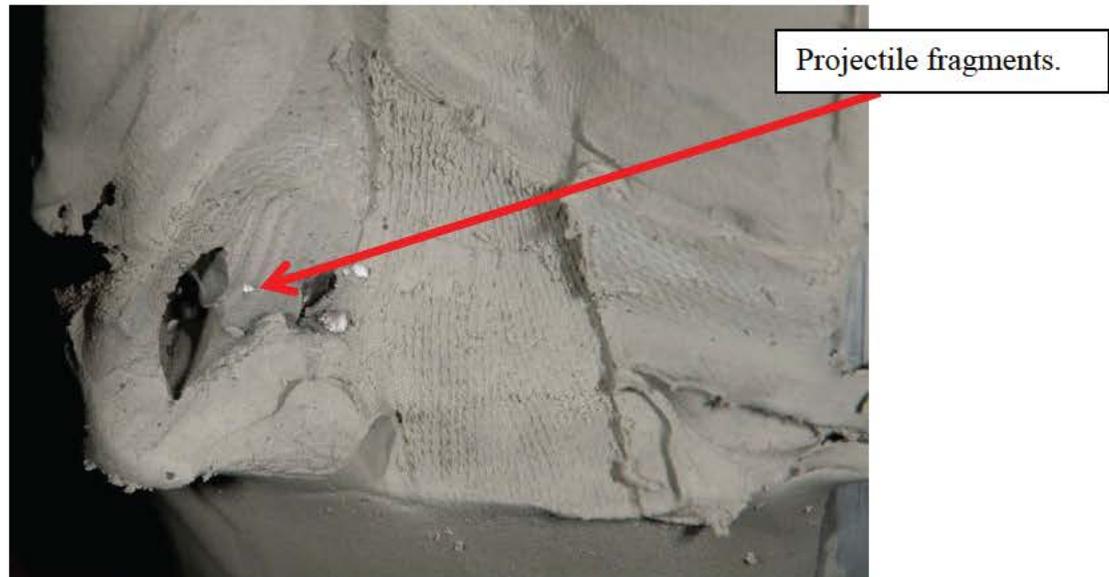
Figure 8: Close-up of post shot of head form.

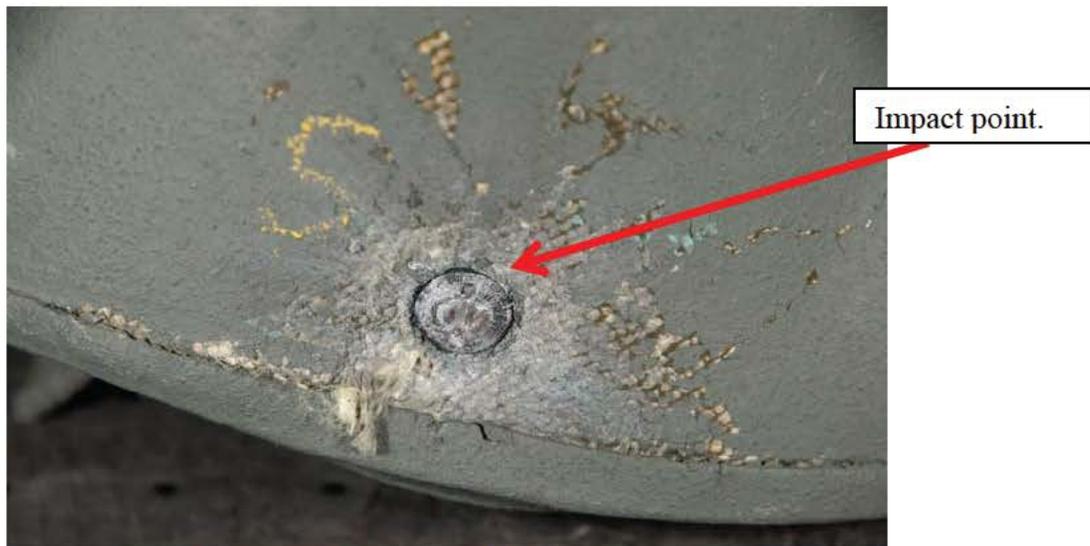
Figure 9: Post shot of helmet exterior.

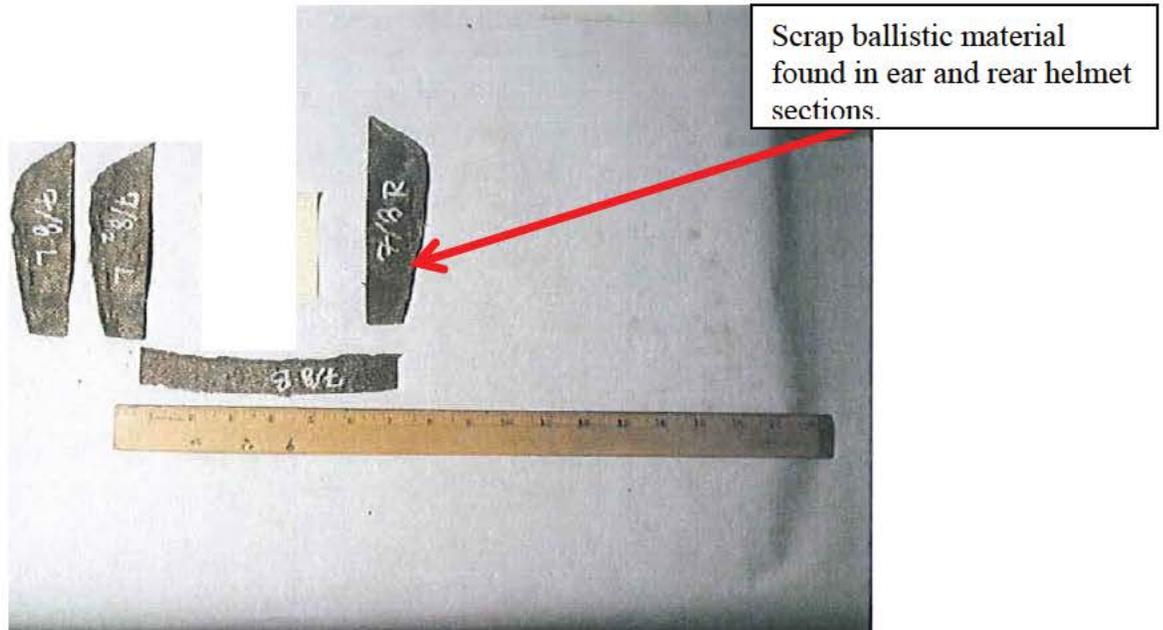
Natick Project Manager Soldier Protection Equipment (Natick) in Natick, Massachusetts, develops and fields state-of-the-art force protection equipment that defeats ballistic and fragmentation threats. Natick examined helmets by deconstructing them to analyze the material consistency and conformity to specifications. Natick's examinations disclosed that scrap ballistic material was inserted into the helmets, and that the ballistic material was cut and stripped. Additionally, Natick found that ballistic plies were cut in half contrary to specifications. Figures 10 – 13 depict Natick's findings during the helmet deconstruction as well as irregularities found in the ballistic material.

Figure 10: Scrap ballistic material inserted into ear and back sections.

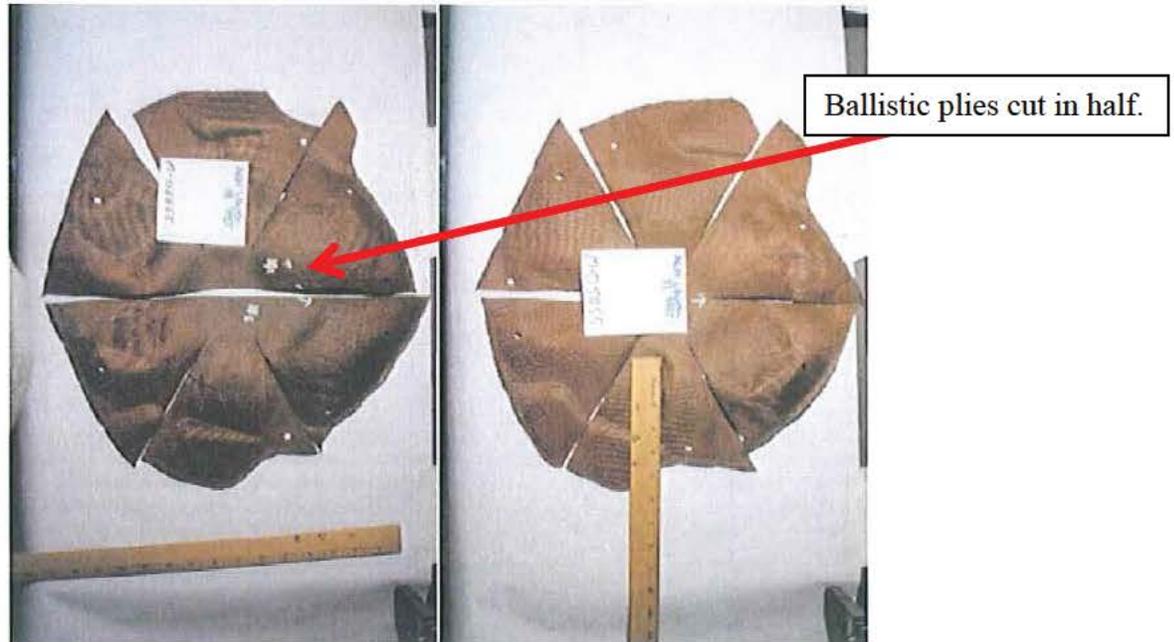
Figure 11: Split ballistic plies.

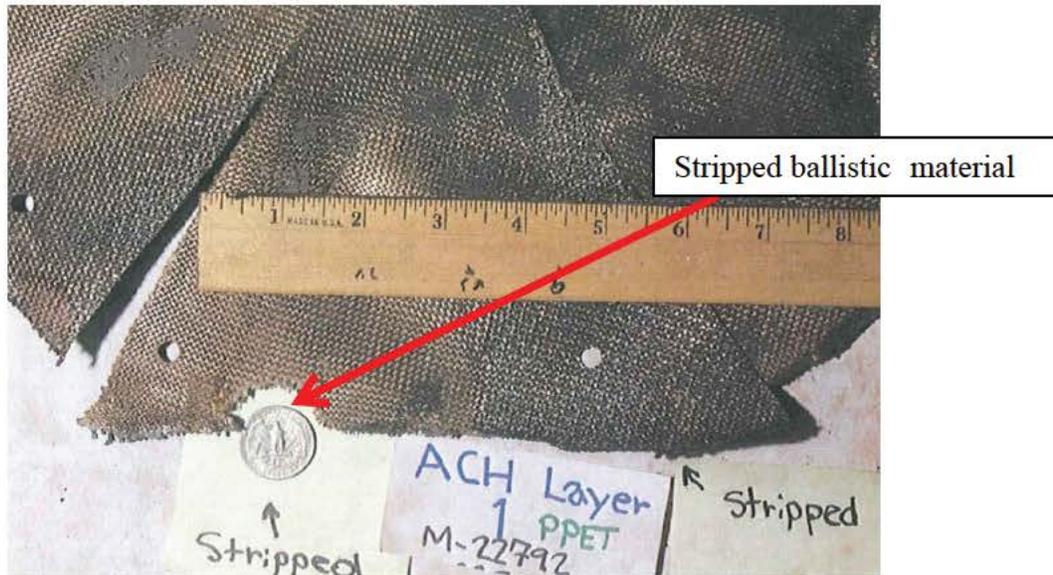
Figure 12: Torn and altered ballistic plies.

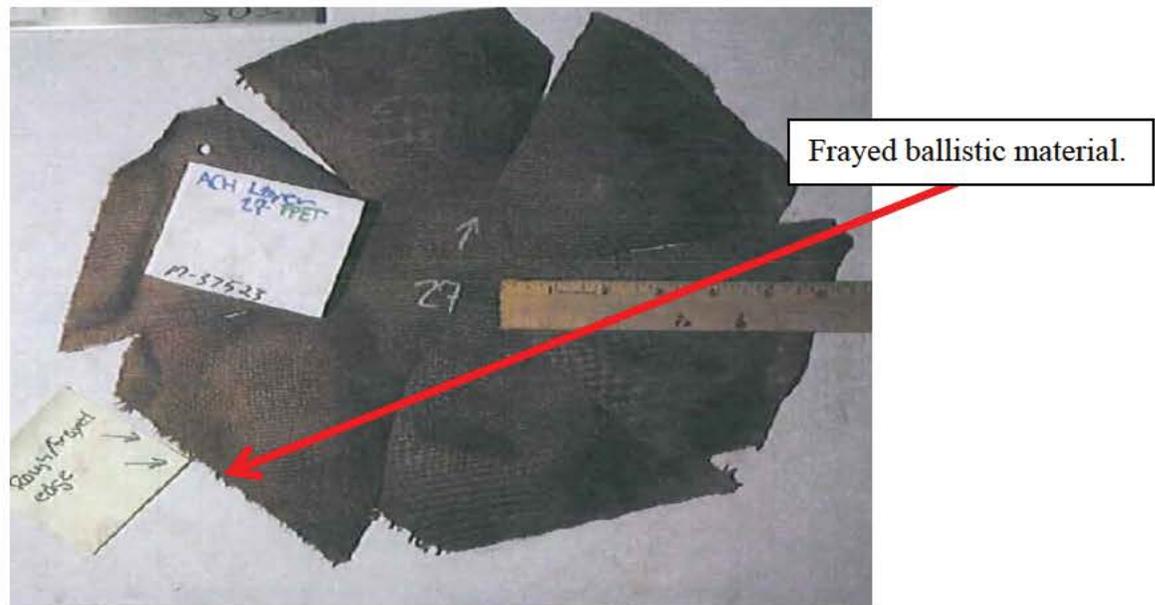
Figure 13: Jagged ballistic material edges.

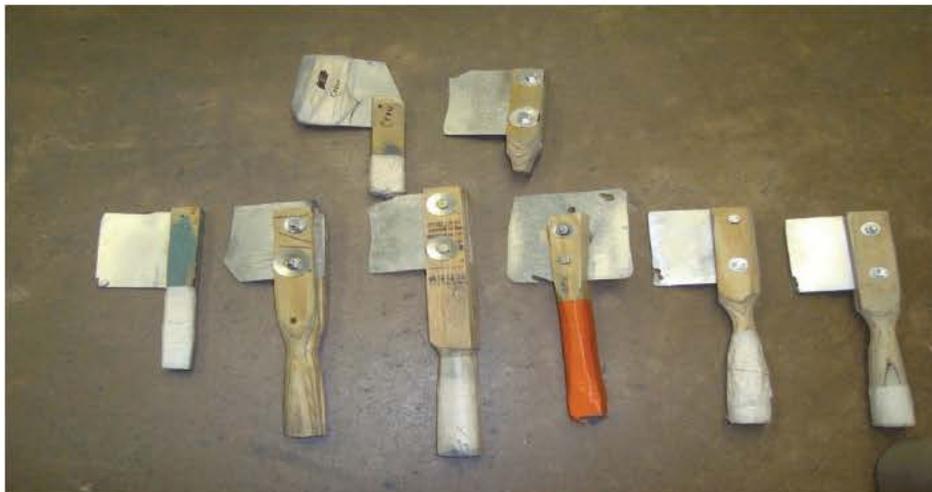
This investigation determined through testimony, inspections, and review of documentation that inmates manufactured unauthorized weapons and tools ("hatchets" and "screw tools"), and that FPI staff allowed inmates to use these contraband items without any controls in complete disregard of BOP and FPI policies. The use of these contraband items adversely affected prison security as well as the safety of inmates and staff as well as factory visitors. We found that FPI staff was aware of the "hatchets" and "screw tools," and that inmates used materials from the factory to make these items with staff oversight [REDACTED] authorized the "hatchets" to remove paint from helmets. Figures 14 and 15 depict the contraband items.

Figure 14: Hatchets.

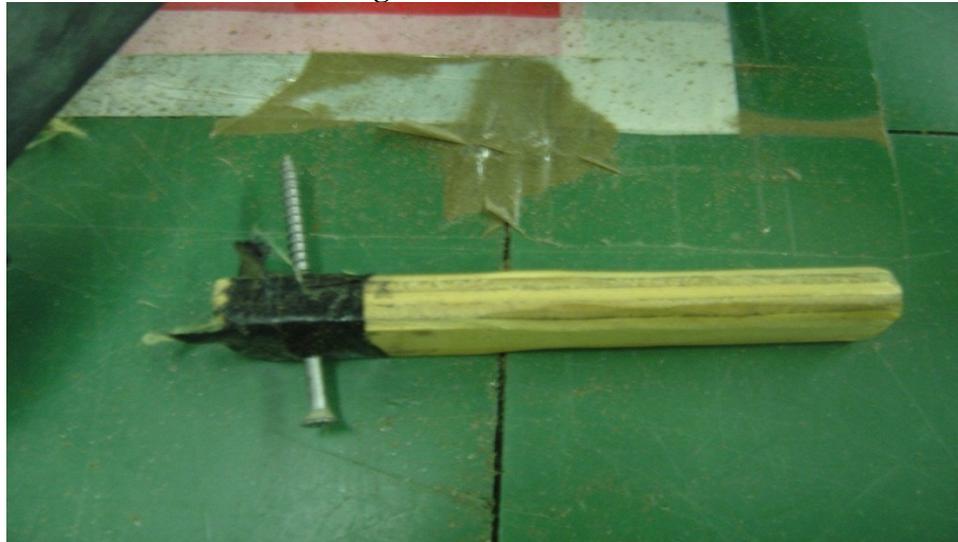
Figure 15: "Screw tool."

use “screw tools” to strip ballistic material, and did not report it. [REDACTED] and [REDACTED] said inmates used “screw tools” to strip Kevlar, and told the OIG the items were in the bottom of a trash can located in a closet.
