Concurrent Inspections of BOP Food Service Operations

Report Number: 25-062 | Posted Date: June 17, 2025 | Division: Evaluation & Inspections

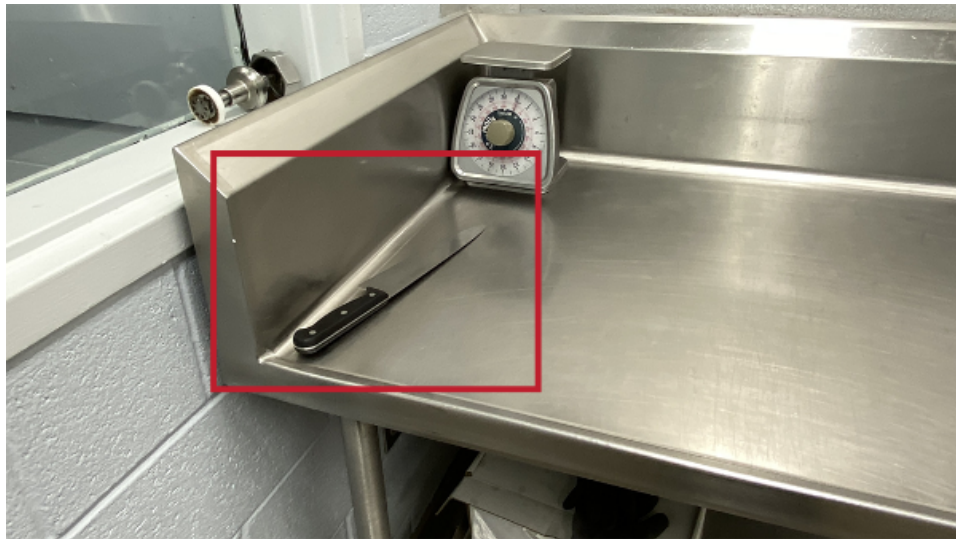
Illustrative of the lack of supervision, during our inspection we found a large unattended and untethered knife in the Camp kitchen. This is an obvious safety risk, as the knife could

be used as a contraband weapon and is a violation of BOP policy, which states that knives must be under the direct supervision of employees and tethered to a stationary object if they are to be used in unsecure food service areas.

Additionally, a BOP employee told us that when the knife is not in use it is stored in an unlocked desk drawer, as opposed to a locked cabinet as required by BOP policy. In response to a draft of this product, the BOP told us that relevant staff have received training on the appropriate management of tools.

An Unsecured and Unattended Knife in the Food Preparation Area of the USP McCreary Camp. Source: OIG, June 2024 (Red Box Added to Highlight the Knife)

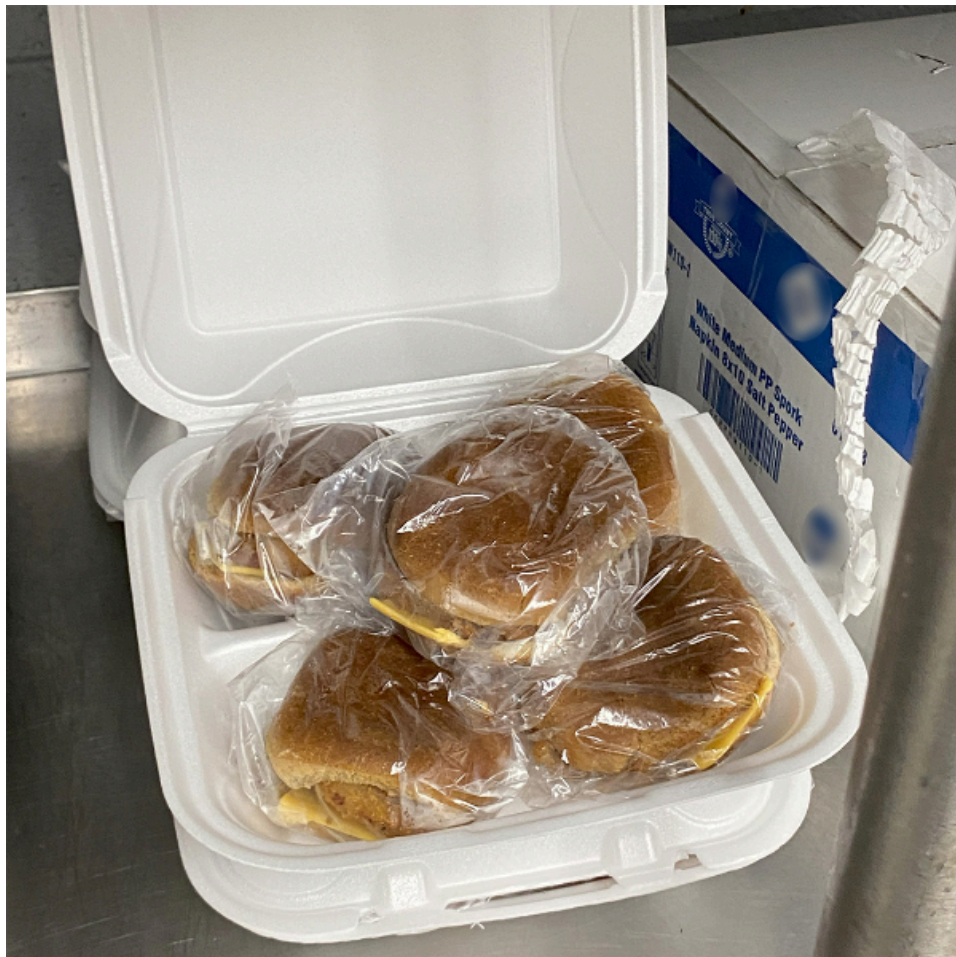
We also found evidence that inmate workers had diverted excess food for their personal use. While seemingly a minor infraction, diverted food is considered contraband and can be used as a type of currency within a correctional environment. Further, there may be food safety risks if inmates consume illicitly acquired food that may not be maintained according to food safety standards.

Containers of Chicken Sandwiches That Inmates
Diverted at the USP. Source: OIG, June 2024

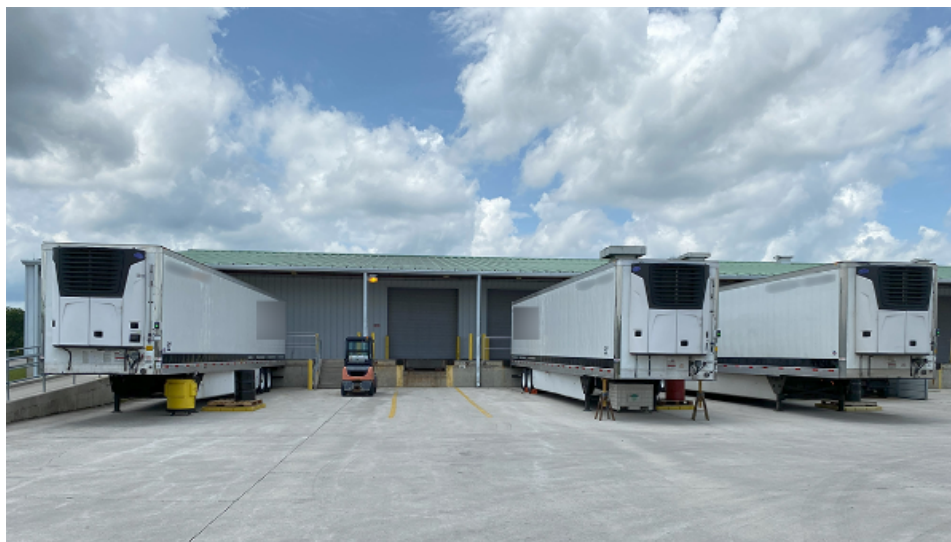
Of USP McCreary's three freezers in the food service warehouse, only one was operational at the time of our inspection. To ensure that there was sufficient space to store frozen foods, the institution was renting three mobile trailers at a cost of \$3,400 per month per trailer. According to a USP employee, the trailers had been rented for at least 2 months prior to our inspections. After reviewing a draft of this product, the BOP reported that the freezer had been repaired and that, sometime between April and May 2025, the freezer trailers had been returned to the vendor.

Three Mobile Trailers Rented by USP McCreary for Frozen Food Storage. Source: OIG, June 2024 (Product Names and Logos Blurred)

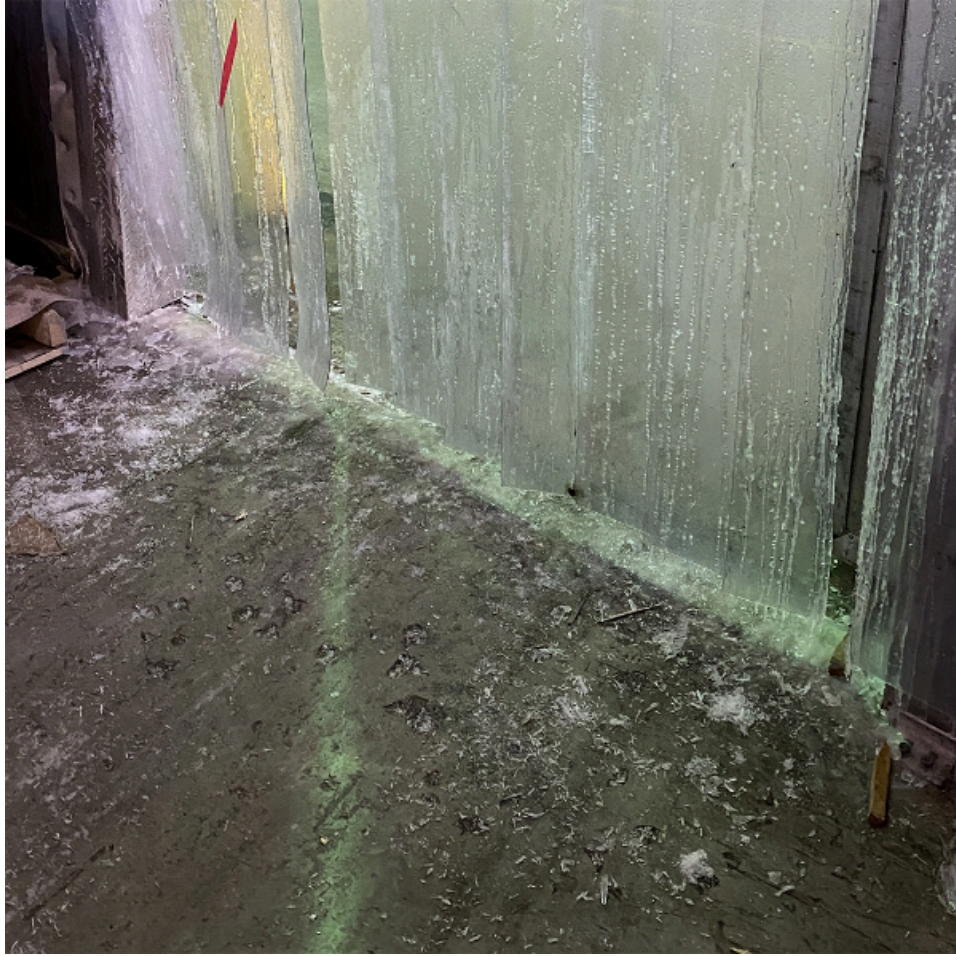
door, which caused warm air to enter the freezer, creating condensation that refroze as ice.

Significant Ice Buildup at the Threshold of the Operational Freezer in the Food Storage Warehouse. Source: OIG, June 2024

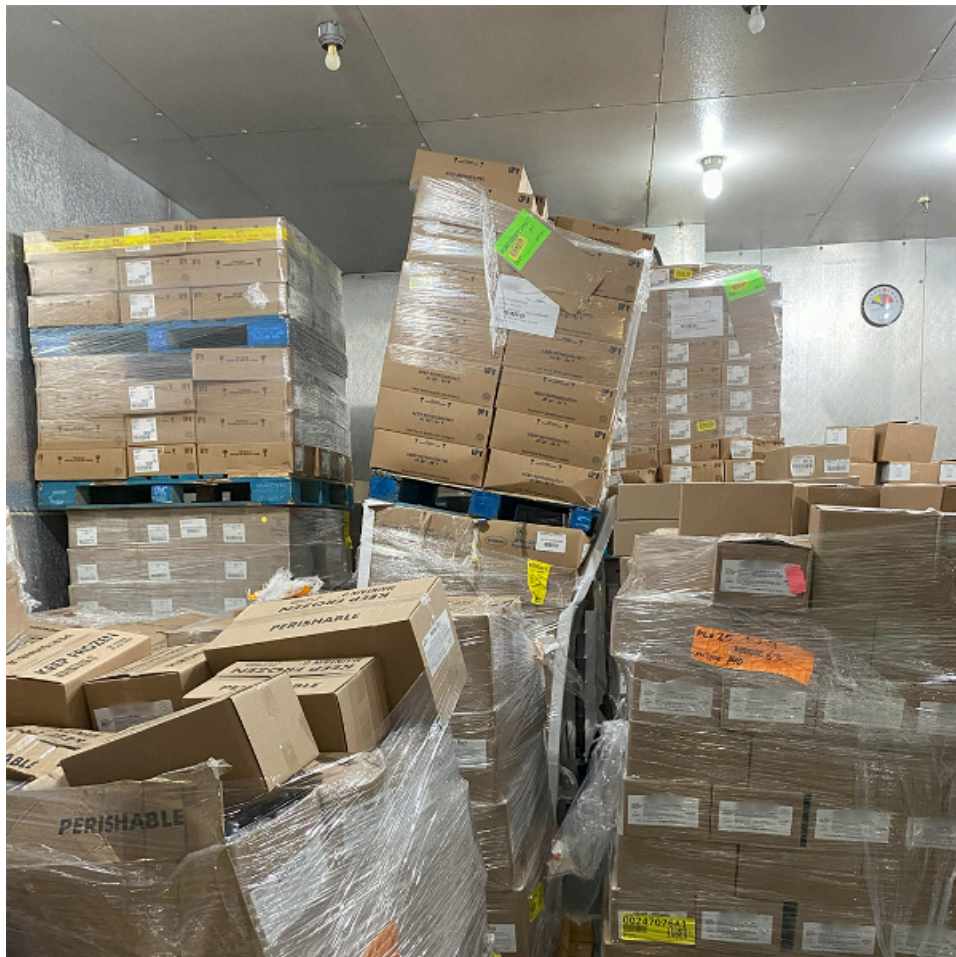
Finally, as it relates to concerns with the one operational freezer, pallets with large amounts of food on them were precariously stacked, creating a serious safety hazard as they may fall on inmates and BOP employees when they are retrieving food.

Precariously Stacked Pallets of Food inside the Operational Food Storage Warehouse Freezer. Source: OIG, June 2024 (Product Names and Logos Blurred)

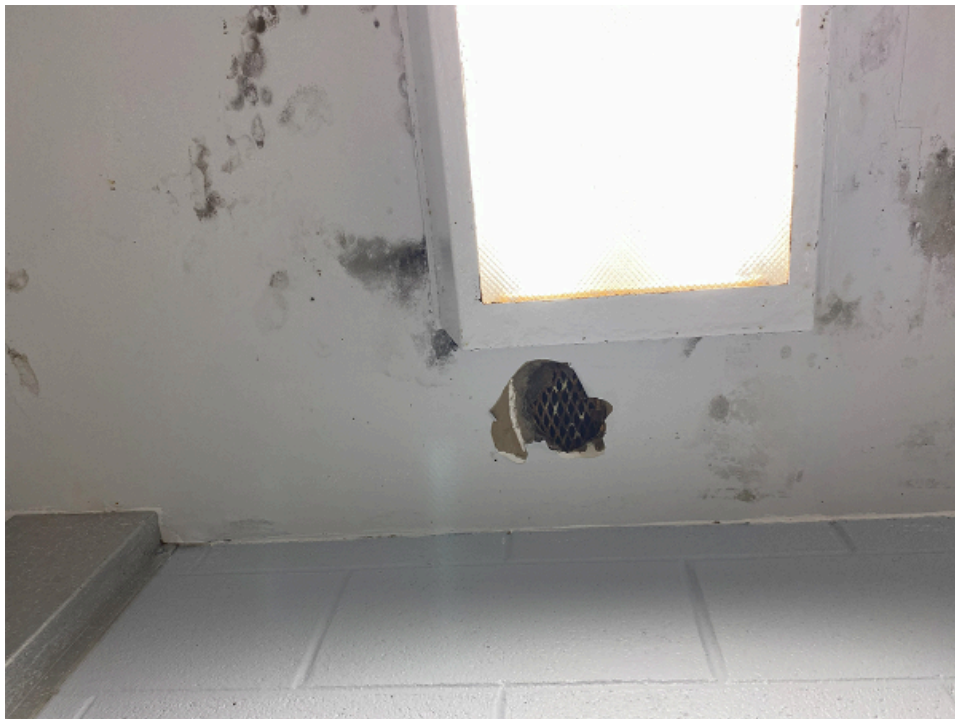
We identified additional concerns related to food service equipment functionality and infrastructure in food service areas. Specifically, in the Camp kitchen, the ventilation system was not operating as intended, causing significant steam build-up and humid conditions. Such humid conditions can foster the growth of mold and create unsafe working conditions for inmates and employees, as well as unsanitary food preparation areas. Further, indicative of humid conditions in the area, we observed multiple water stains and a hole in the ceiling. In April 2025, we asked the BOP for an update on the ventilation system; the BOP told us that the vent hoods had been repaired and were operational.

Water Stains and a Hole in the Ceiling of
the Camp Kitchen. Source: OIG, June 2024

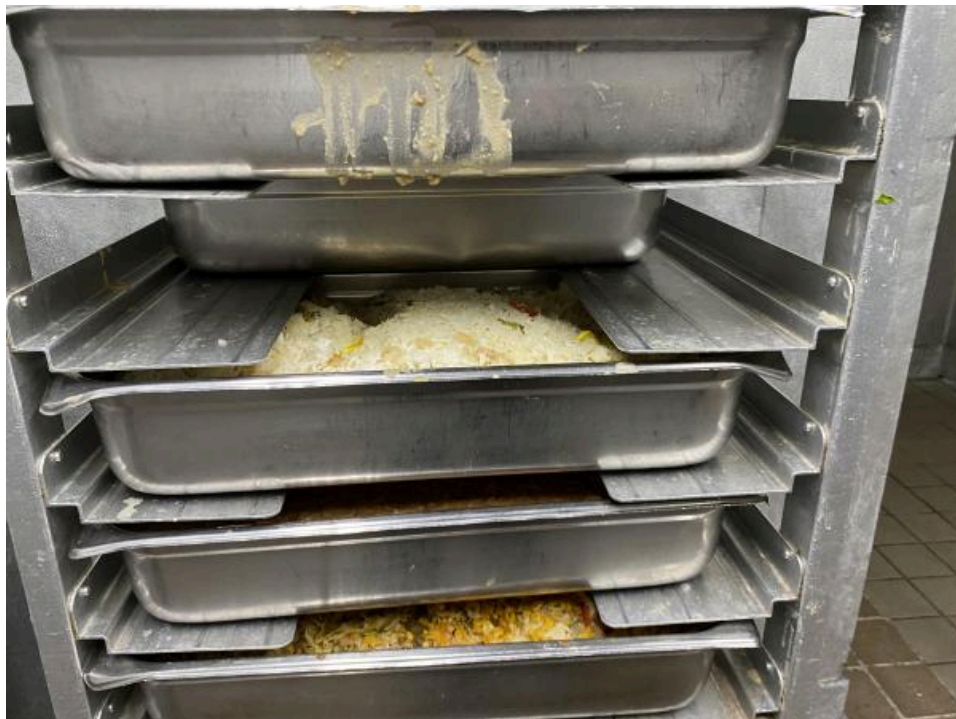
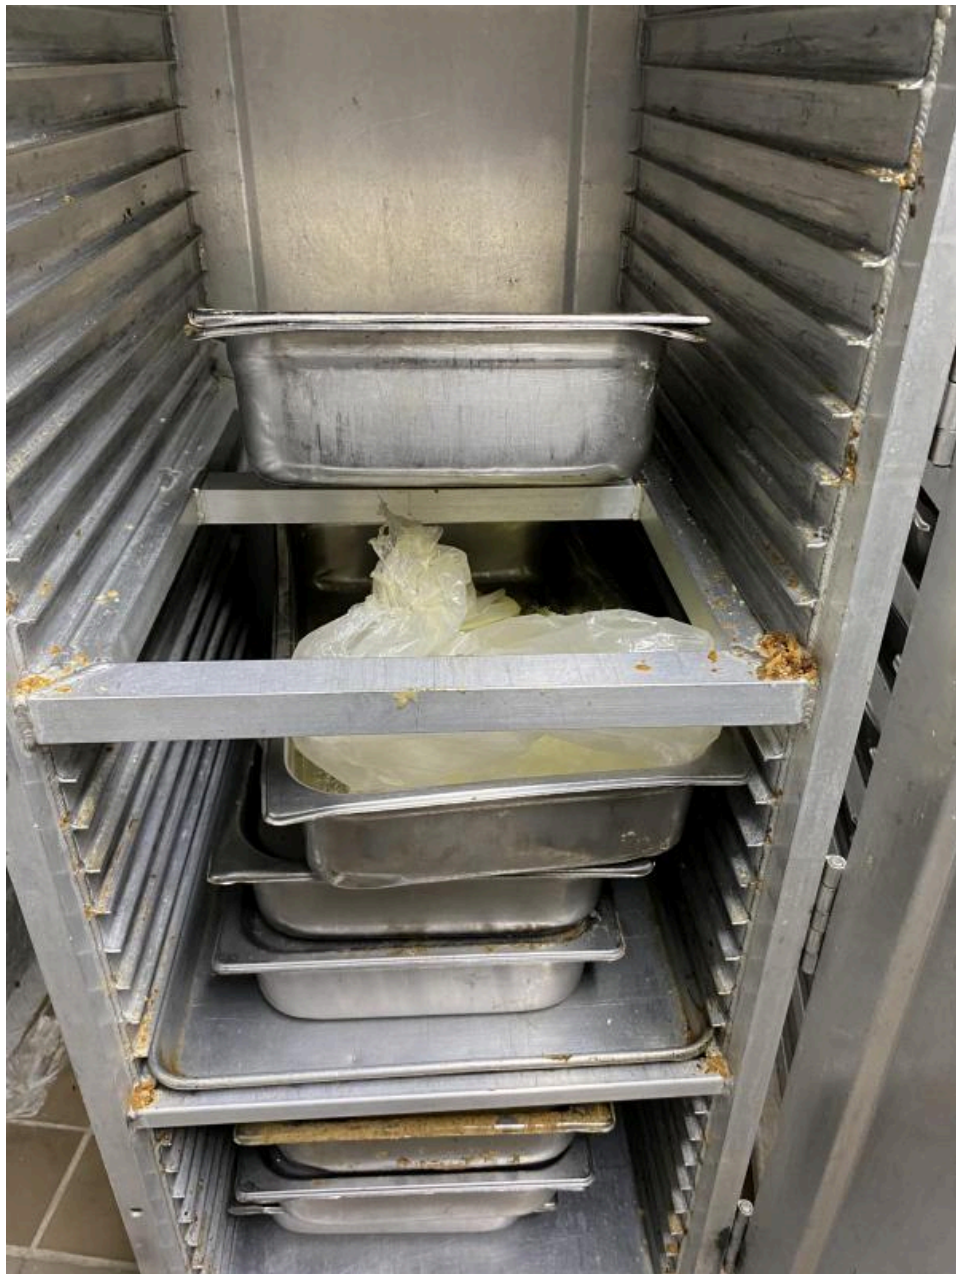
At USP McCreary, we found a dirty kitchen that had the pervasive smell of raw meat. Further, in a broken walk-in refrigerator with a temperature of 80 degrees F, we found a large amount of day-old prepared food that had been left in uncovered serving trays. We also found that there was no soap in a bathroom used by inmates who prepare food. The lack of readily available soap for inmates who prepare food is an obvious sanitation concern and undermines institution efforts to comply with BOP policy, which requires inmates who work in food service to employ proper handwashing techniques. According to Food Service Department employees, inmates could access soap if they requested it.

We also found serious sanitation issues in the USP kitchen, which was dirty and had a pervasive smell of raw meat. Further, in a broken walk-in refrigerator we found a large amount of day-old prepared food that had been left in uncovered serving trays. The Food Service Administrator believed that inmates who worked in food service the day prior had hidden the food in the refrigerator to avoid the work of disposing of the food and cleaning the trays. Although the Food Service Administrator told us that there was no intention of serving this leftover food to inmates, the presence of this volume of food, which was held at a temperature of 80 degrees F at the time of our inspection, created myriad food safety and sanitation concerns. According to the BOP's response to a draft of this product, the inoperable walk-in refrigerator is not being used to store food and there is no longer a raw meat odor in the kitchen area.

Day-old Prepared Food Found in a Broken Walk-in Refrigerator. Source: OIG, June 2024

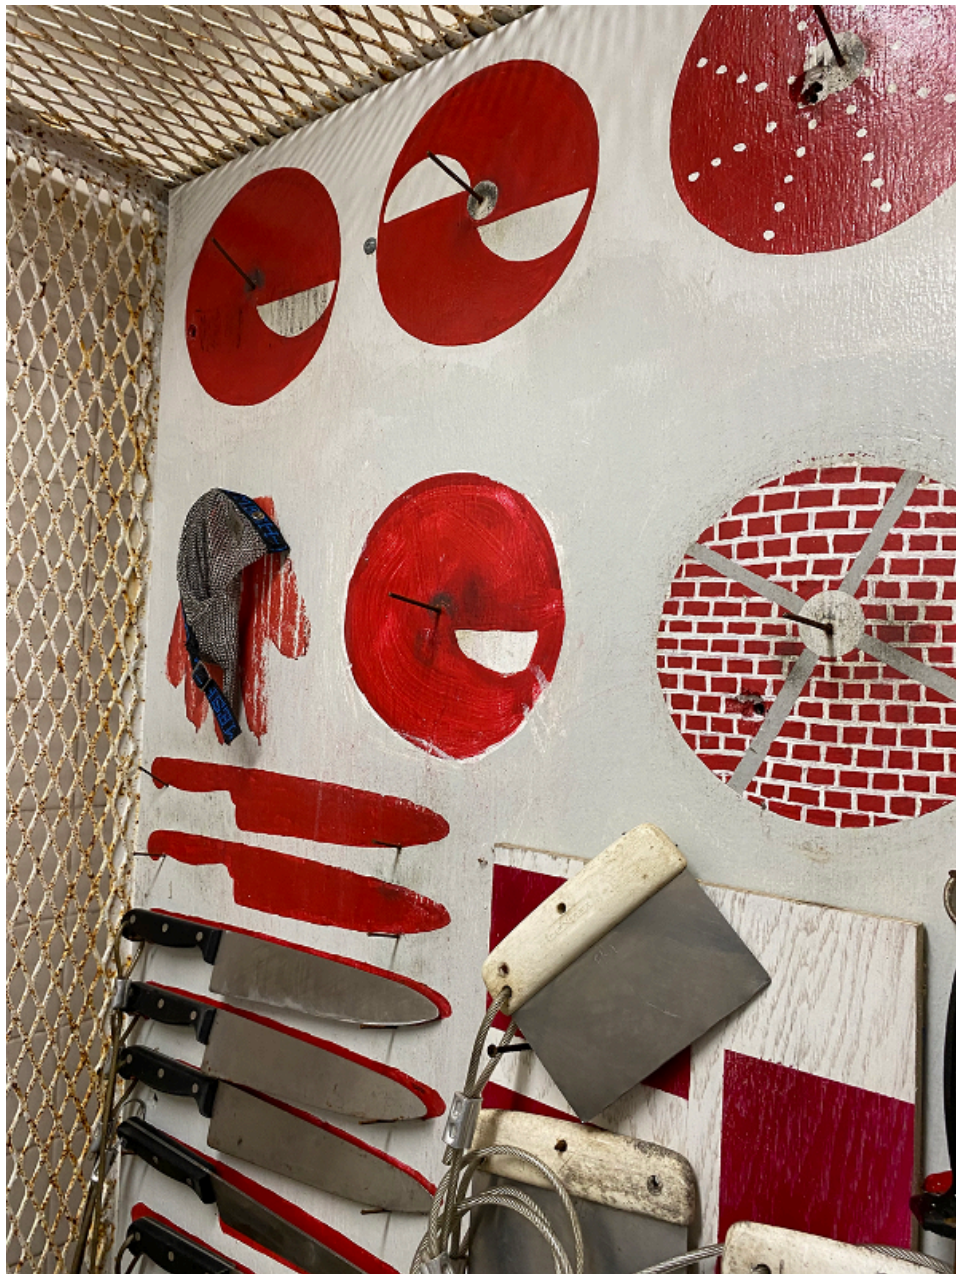
Illustrative of the Warden’s statement, we found that Food Service Department employees were not appropriately tracking the use of knives and other sharp tools at the FCI, which is a serious safety risk as these tools could be used as contraband weapons. It is also a violation of a BOP policy, which states that all knife usage must be tracked via a shadow board with markers that indicate when a knife is in use and who has it. As can be seen in the image below, the required markers of two knives and five other sharp tools were absent from the shadow board at the time of our inspection. According to the Warden, the missing markers were replaced.

Knife Box Shadow Board With Missing Tracking Markers for Two Knives and Five Other Sharp Tools. Source: OIG, June 2024

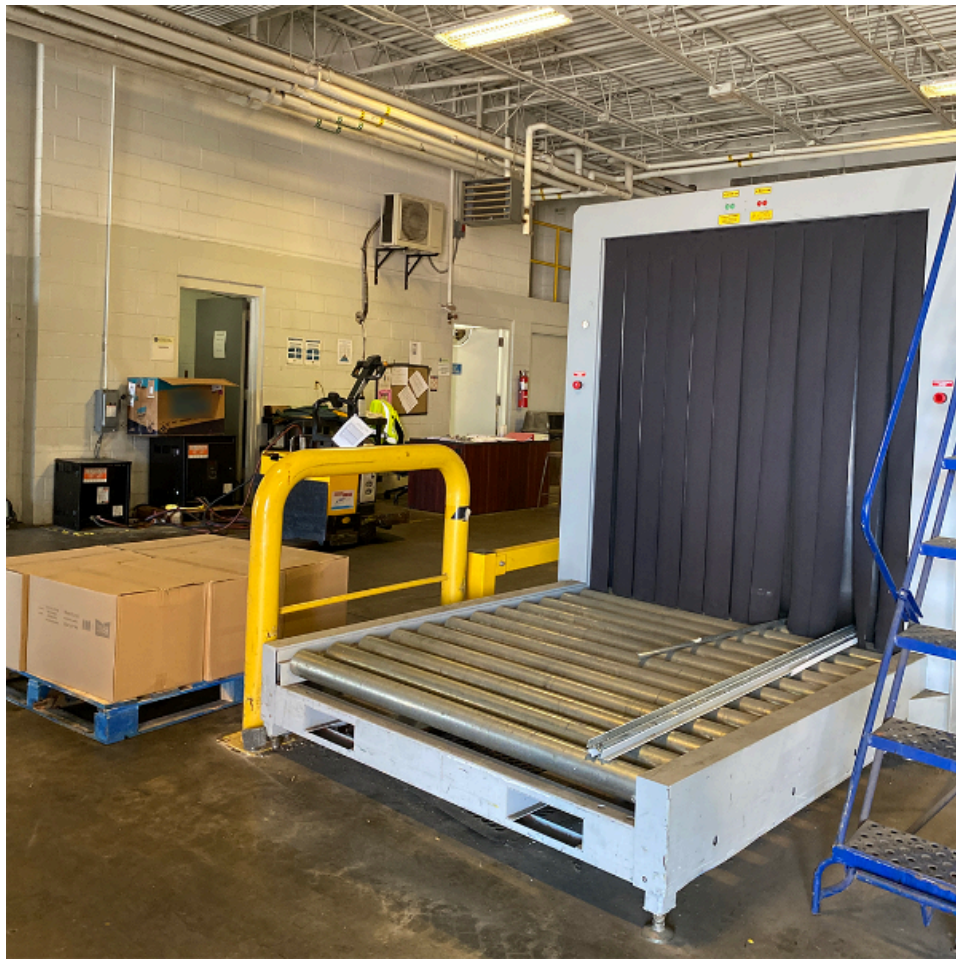
examine incoming food shipments for contraband. Additionally, the BOP's response stated that manual searches are more effective than pallet x-ray machines at identifying small items concealed within large pallets of food. Notwithstanding the value of manual searches, we believe that pallet x-ray machines can still assist the BOP in preventing the introduction of contraband. This sentiment was shared by the responsible employee we interviewed during our inspection who confirmed that manual inspections of food shipments do occur but also told us that that inspections of incoming food shipments would be more thorough if the institution's pallet x-ray machine were operational. As of May 2025, the x-ray machine was still broken, but efforts were underway to source parts for a repair.

Inoperable Pallet X-ray Machine in the Food Storage Warehouse.
Source: OIG, June 2024 (Product Names and Logos Blurred)

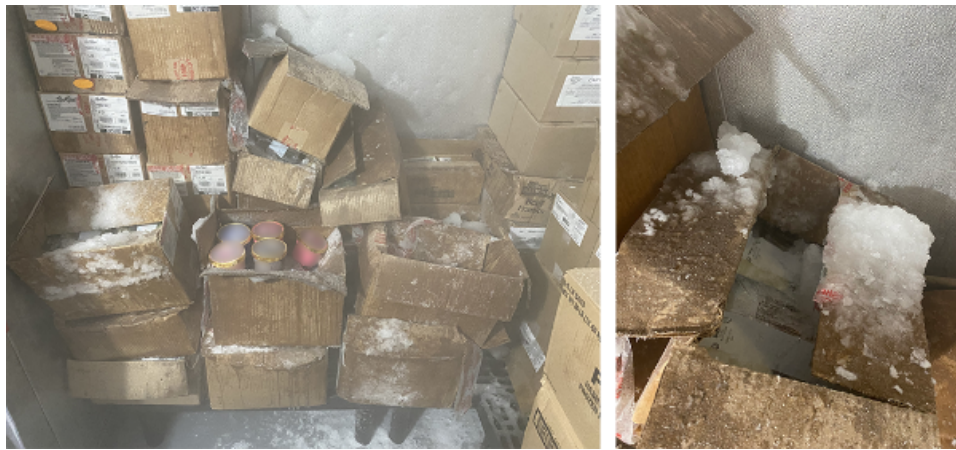
Significant Ice Buildup on Food Stored in a Freezer.

After our observations, the Warden told us that the thermostat had been recalibrated on the first refrigerator with elevated temperatures and that replacement doors for the other refrigerator and the freezer had been received and would be installed during our visit. According to the BOP, as of April 2025 all refrigerators and freezers were operational.

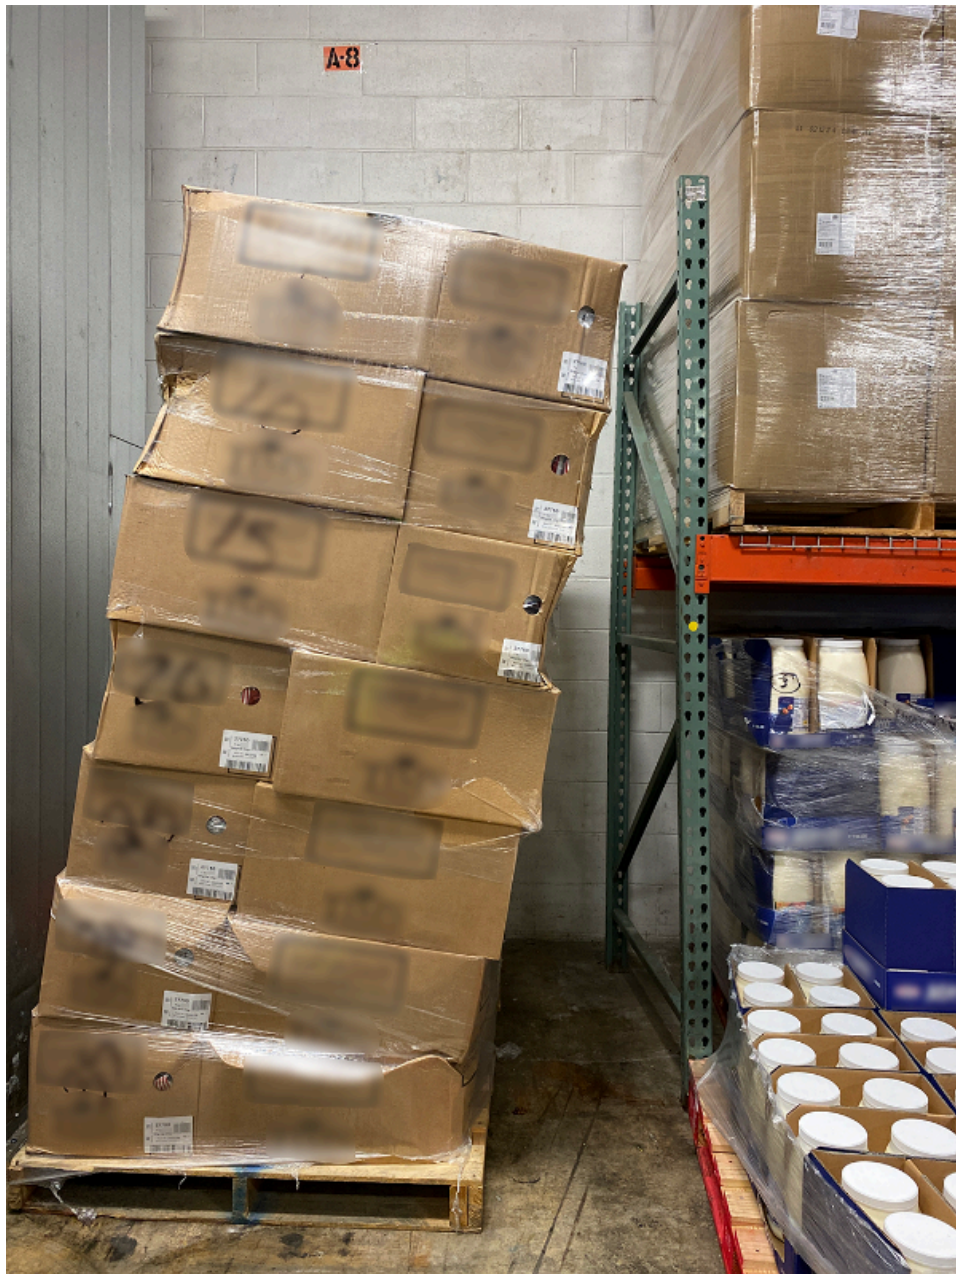
In addition to excessive heat in the FCI kitchen at the time of our inspection, we identified one additional workplace safety issue in the food warehouse: a pallet of food was precariously stacked, creating a serious safety hazard as food packages could fall on inmates and BOP employees working in the area.

Precariously Stacked Boxes of Food in the Food Storage Warehouse.

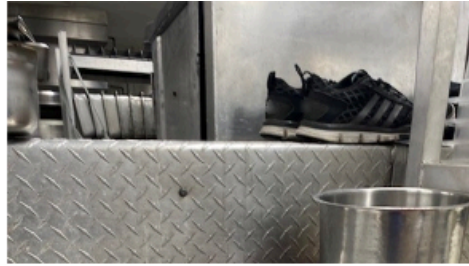
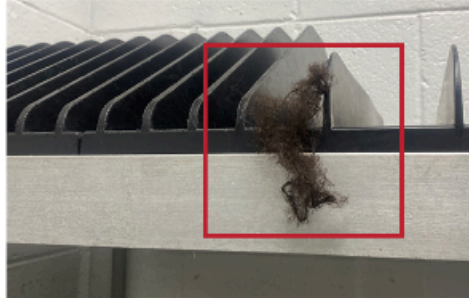
Third, we also found what appeared to be a used hairnet on a drying rack in the dishwasher room. After our inspection, the BOP repaired the warehouse door.

Top Left, Food Service Warehouse Receiving Door That Could Not Fully Close; *Top Right*, a Pair of Shoes Found on Top of a Kitchen Surface Inside the Food Service Area; *Bottom Right*, A Used Hairnet Resting on a Drying Rack in the Dishwasher Room. Source: OIG, June 2024 (Red Box Added to Highlight the Used Hairnet and Product Names and Logos Blurred)

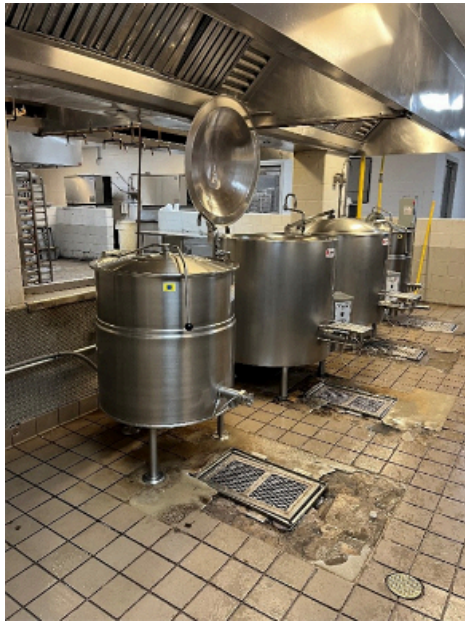
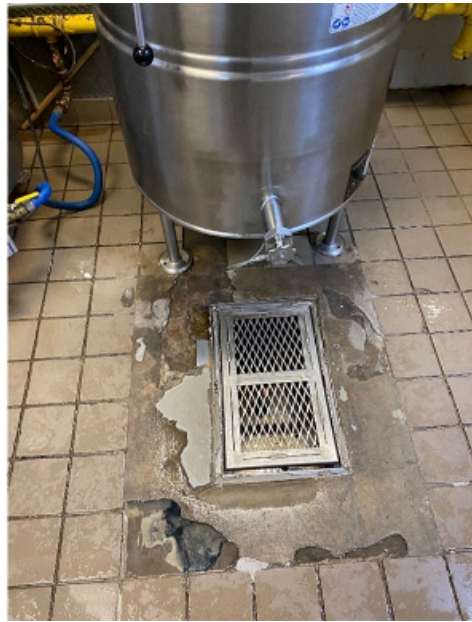
Second, we found many damaged and missing floor tiles in the dishwasher area and around large cook kettles in the USP kitchen. Several employees told us that staff have sustained slip-and-fall injuries on the uneven kitchen floor tiles, particularly when the tiles were wet. In April 2025, we asked the BOP for an update on the floor tiles, and the BOP provided photographs showing that the area around the broken floor tiles had been patched and leveled.

Left and Right, Degraded Floor Tiles near Large Cook Kettles in the Kitchen. Source: OIG, June 2024

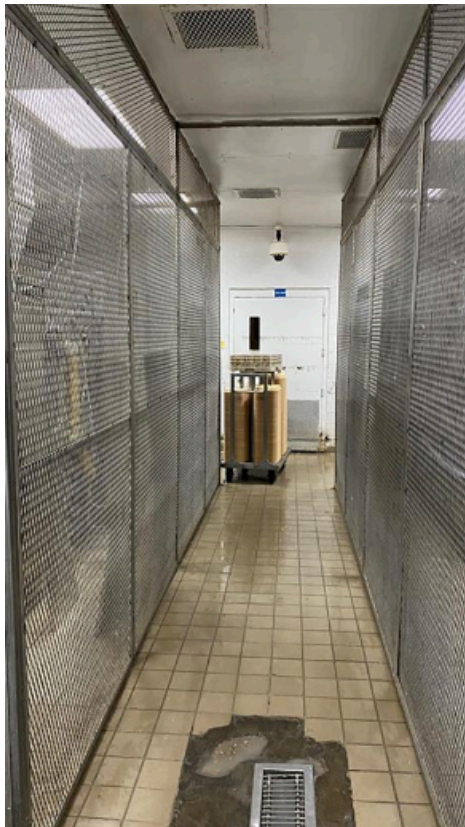
Left and Right, Degraded Floor Tiles near Dishwashers in the Kitchen. Source: OIG, June 2024

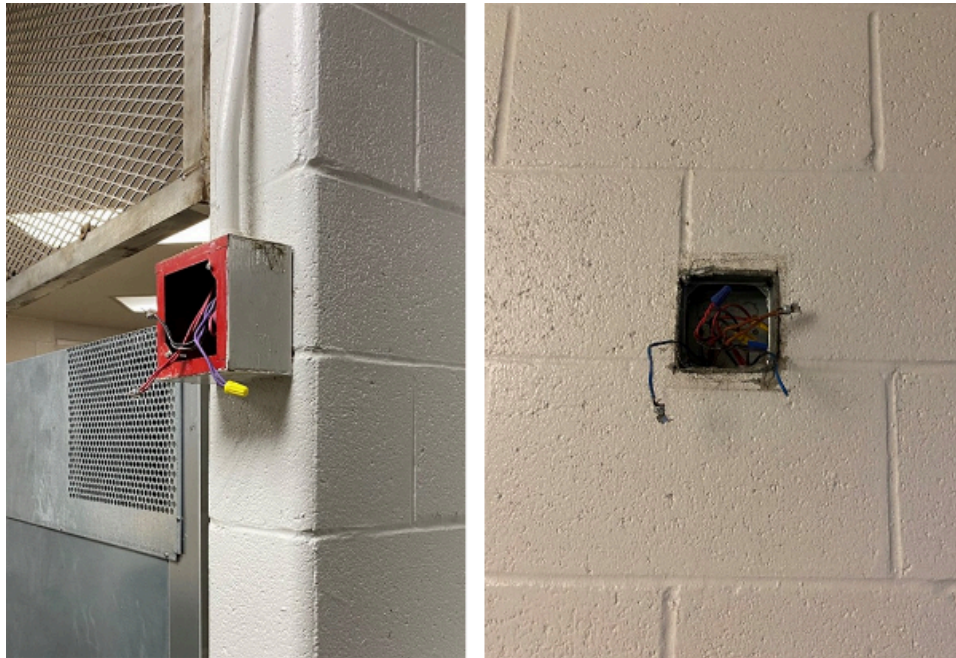
Left, Exposed Electrical Wires Without a Safety Plate in the Secure Cafeteria Serving Area, Right, Exposed Electrical Wires Without a Safety Plate in the Kitchen Area. Source: OIG, June 2024

faceplate, or fixture canopy. In April 2025, we asked the BOP for an update on the uncovered boxes and exposed wires and the BOP provided photographs showing that the boxes and the wires had been covered.

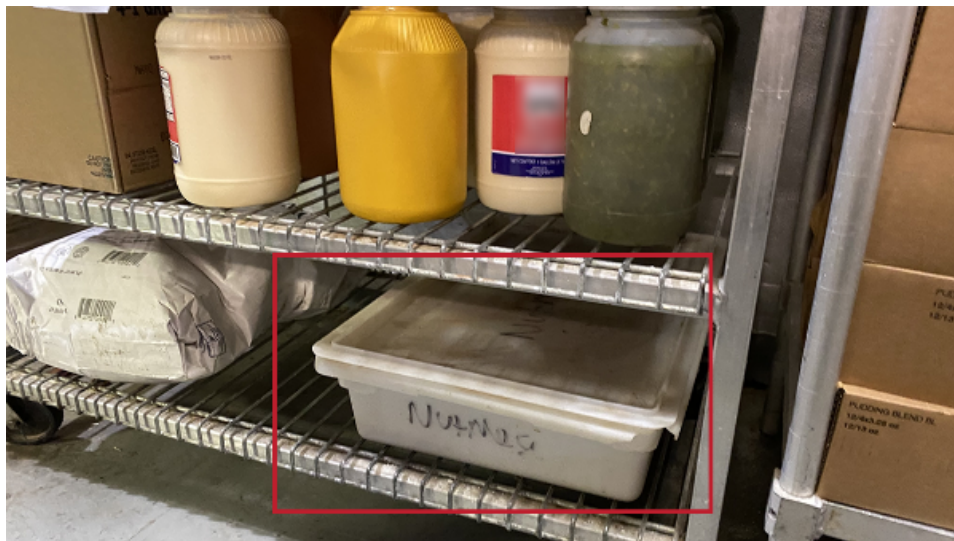
Like other institutions we inspected, MCC Chicago does not have security cameras in its food service warehouse. However, unlike the other institutions, MCC Chicago's warehouse is located 10 miles from the institution and inmates do not work there, thus mitigating the risk associated with a lack of cameras. We did identify one contraband-related concern in a food storage area adjacent to the kitchen. Specifically, nutmeg—which contains naturally occurring chemicals that may cause intoxication if consumed in large amounts—was stored in an unlocked container that could be accessed by inmates who work in food service. This is in violation of BOP policy, which requires nutmeg to be locked inside a cabinet to prevent misuse. In response to a draft of this product, the BOP said that MCC Chicago no longer maintains nutmeg at the institution.

Unsecured Nutmeg in a Food Storage Area Adjacent to the Kitchen. Source: OIG, June 2024 (Red Box Added to Highlight the Nutmeg and Product Names and Logos Blurred)

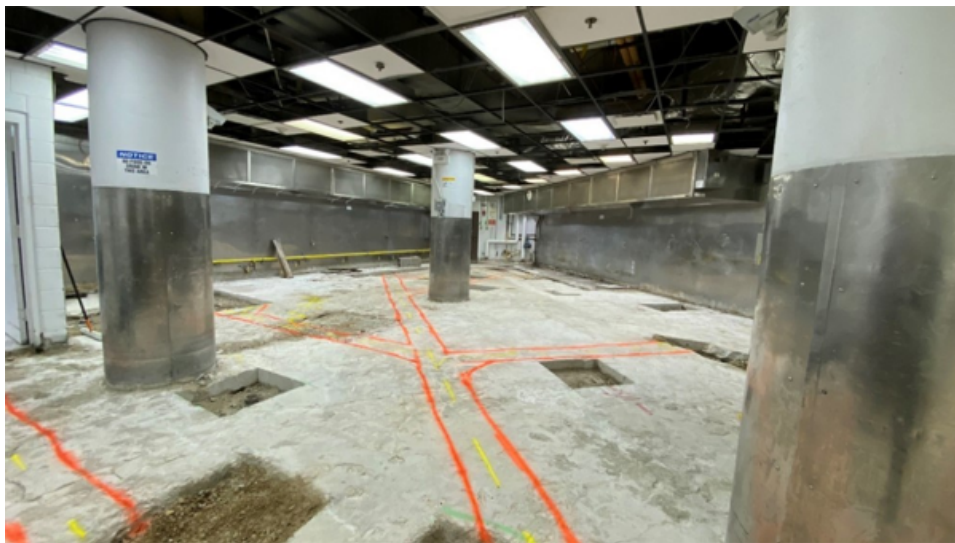
- Due to broken water pipes and poor drainage that damaged the floor of MCC Chicago's kitchen, the kitchen was undergoing a complete renovation with an anticipated cost of at least \$700,000.

At the time of our inspection, MCC Chicago's kitchen was undergoing major renovations to address structural problems caused by broken pipes and improper floor drainage. During the renovation, MCC Chicago planned to replace several ovens, cook kettles, and a dishwasher. Due to ongoing renovations, at the time of our inspection all inmate meals were being prepared in a temporary kitchen and delivered to inmate housing units. The BOP initially anticipated a \$300,000 budget for the kitchen renovation; however, at the time of our inspection, costs had risen to over \$700,000 due to the volume of necessary repairs. Although the BOP was able to renovate the kitchen at MCC Chicago, it has been unable to make other major repairs at institutions across its enterprise. This is because the BOP has a large and growing list of unfunded modernization and repair needs and has historically failed to request funding to address them. As of 2024, the BOP estimated that it had a \$3 billion backlog of unfunded infrastructure repairs across all of its institutions.

MCC Chicago's Ongoing Kitchen Renovation. Source: OIG, June 2024

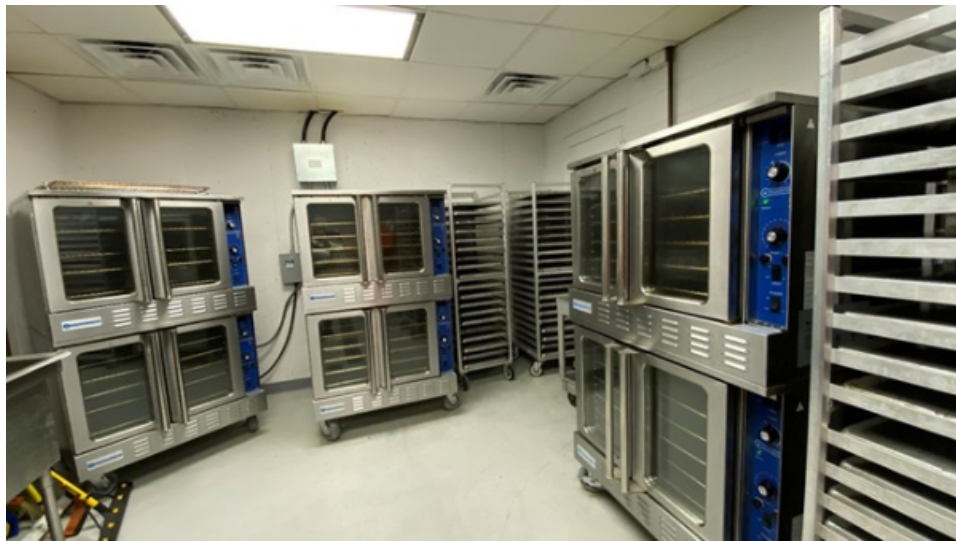
rice or beans and without a fryer, they could not deep-fry chicken. The Food Service Administrator told us that he did his best to ensure that the inmates received reasonable alternatives. For example, the institution was able to bake potatoes in lieu of rice and prepare oven-baked chicken in lieu of traditionally fried chicken. According to the BOP, the MCC Chicago renovation project was completed in November 2024. In addition to the replacement of the drainage system and floor, the project included the installation of 12 ovens, a mixer, a dishwasher, 4 cook kettles, and a waste disposal system.

Ovens in the Temporary Kitchen. Source: OIG, June 2024 (Product Names and Logos Blurred)

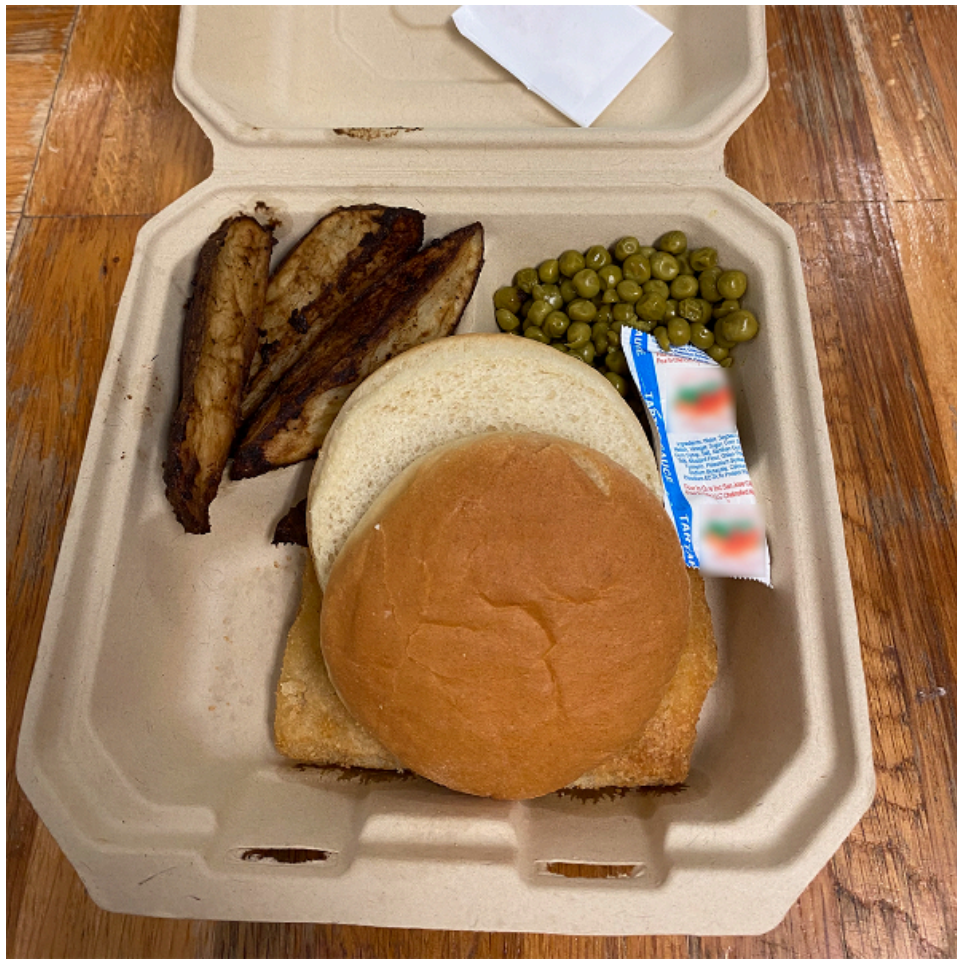
Example of a Meal That Could Be Prepared in the Temporary Kitchen:
Fish Patty Sandwich, Baked Potato Wedges, and Peas. Source: OIG, June
2024 (Product Names and Logos Blurred)

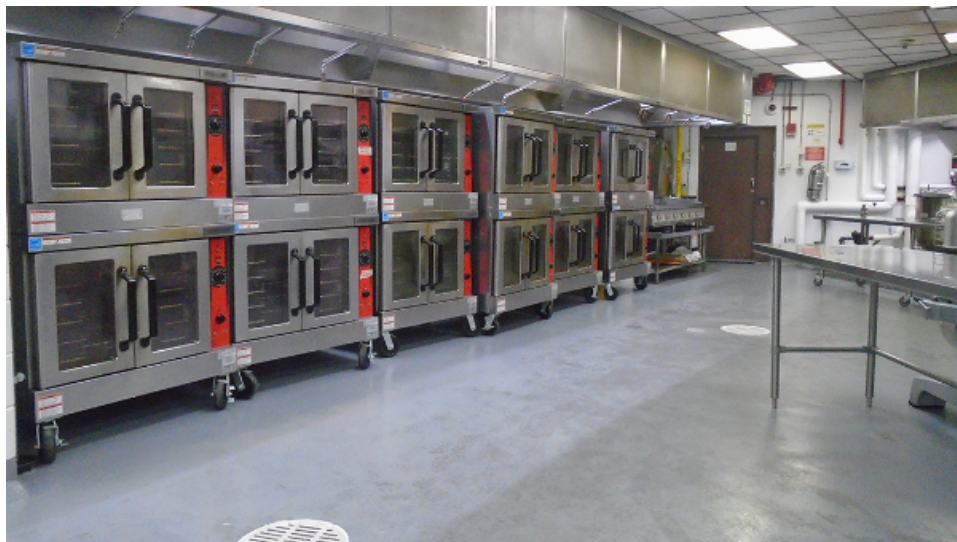
Ovens in the Renovated Kitchen. Source: BOP,
April 2025 (Product Names and Logos Blurred)

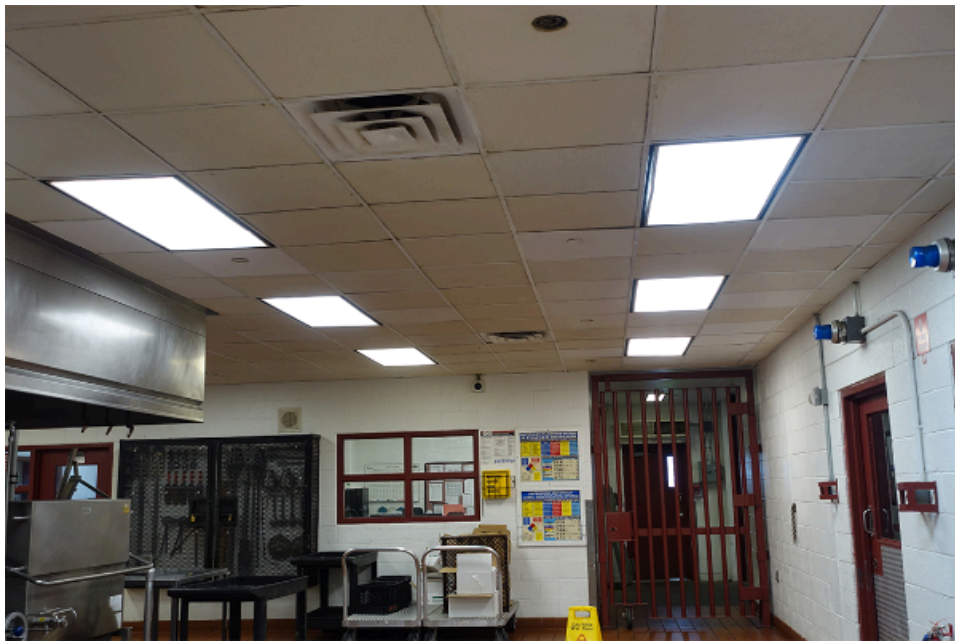
In the FCI kitchen, we found drop ceilings that enabled inmates to hide food and food service items. Employees told us that they have consistently found stolen food inside the drop ceiling space and they believe that inmates are transporting food items from the kitchen to other areas of the FCI. While seemingly a minor infraction, diverted food is considered contraband and can be used as a type of currency within a correctional environment. Further, there may be food safety risks if inmates consume illicitly acquired food that may not have been maintained according to food safety standards. In response to a draft of this product, the BOP stated that staff now conduct more frequent searches in areas that have drop ceilings.

Drop Ceiling in the FCI Kitchen Where
Inmates Hide Food. Source: OIG, June 2024

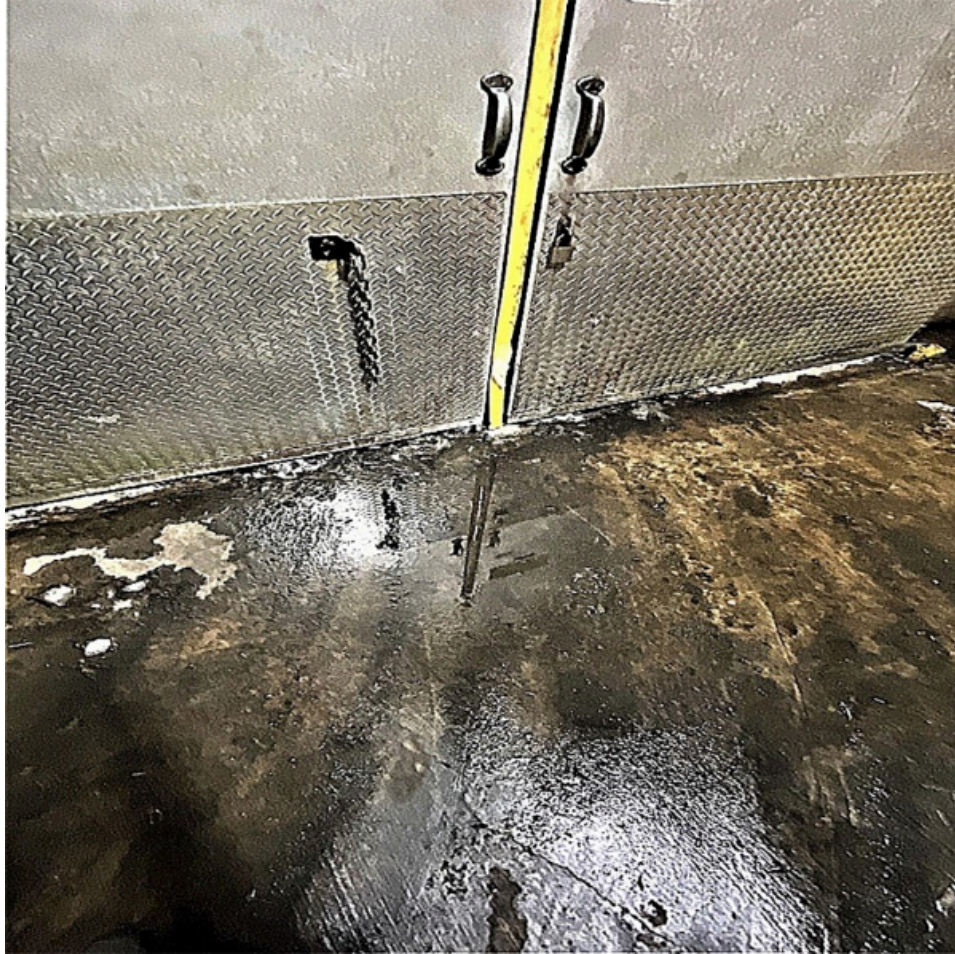
issue at USP McCreary, where a food service employee told us that a faulty seal on a freezer door caused warm air to enter the freezer, creating condensation that refroze as ice. In response to a draft of this product, the BOP said that it had addressed the ice accumulation issue at FCC Allenwood by replacing faulty gaskets on the freezer door and posting signage to remind employees to secure the door.

Ice Buildup on the Floor near the Entrance to a Freezer in the Food Storage Warehouse. Source: OIG, June 2024

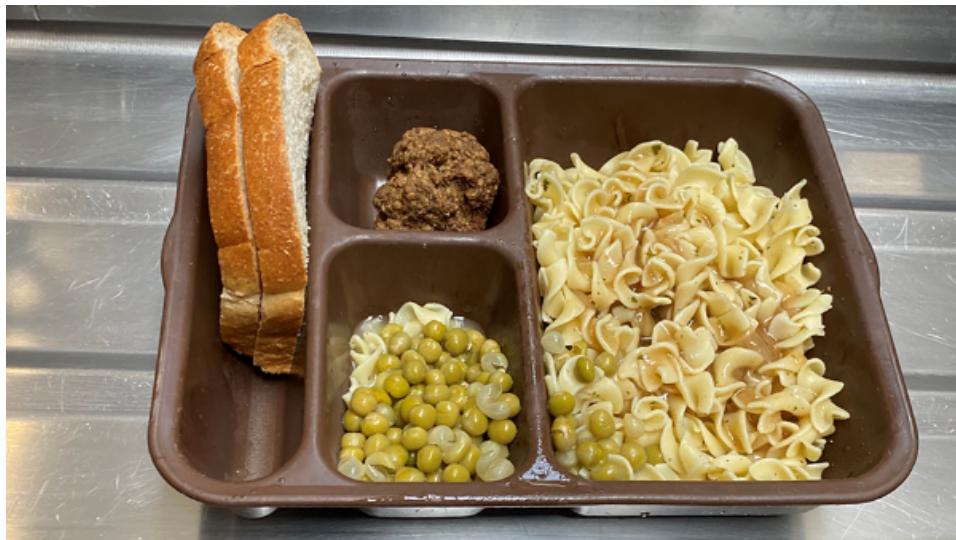
A Meal Served at the USP. Source: OIG, June 2024

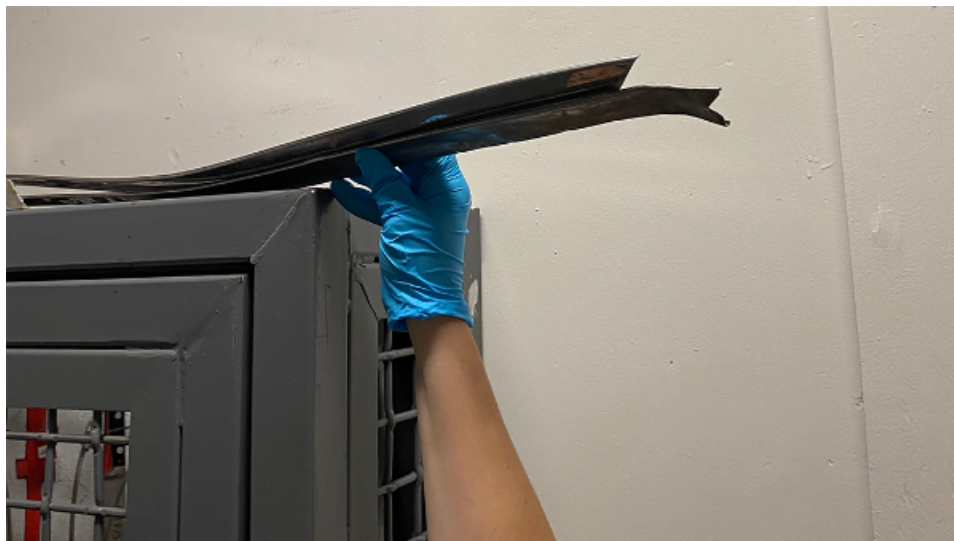
With regard to contraband mitigation procedures in the Food Service Department, we found that FCI Mendota complied with BOP policy for the management and tracking of knives and other dangerous tools and that all knives and kitchen tools were stored and tracked appropriately in the FCI and Camp. However, we found a large, sharp piece of metal, which could be fashioned into a weapon, on top of the locked knife cage in a locked tool room adjacent to the FCI's kitchen.

A Large, Sharp Piece of Metal Found on Top of the Locked Knife Cage in a Tool Room Adjacent to the FCI's Kitchen. Source: OIG, June 2024

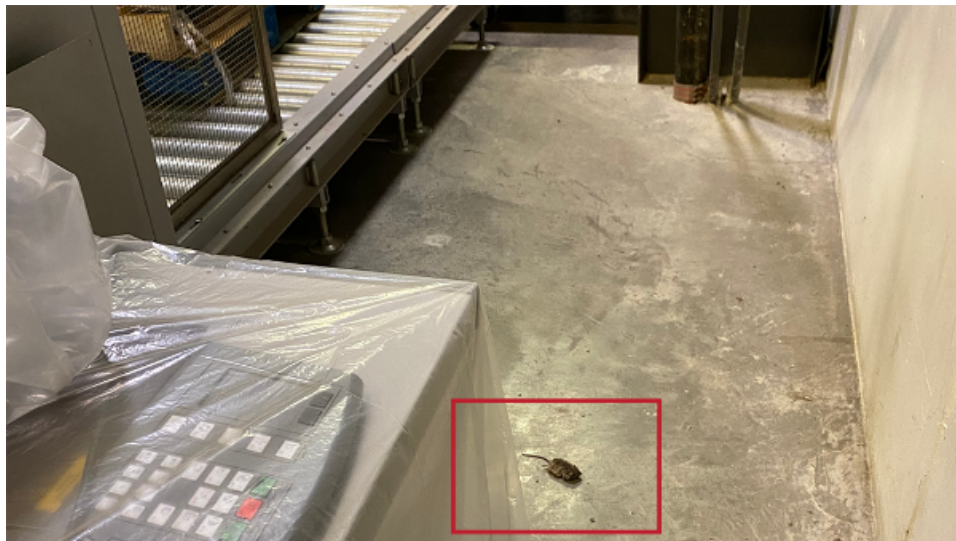
pallet x-ray machine had not been working for at least 2 years prior to our inspection. In response to a draft of this product, the BOP told the OIG that BOP policy does not require the use of pallet x-ray machines and that institutions do not rely solely on them to examine incoming food shipments for contraband. Additionally, the BOP's response stated that manual searches are more effective than pallet x-ray machines at identifying small items concealed within large pallets of food, and we note that a responsible employee from FCI Mendota told us during our inspection that manual inspections of food shipments do occur. Notwithstanding the value of manual searches, we believe that pallet x-ray machines can still assist the BOP in preventing the introduction of contraband.

Dead Rodent behind the Pallet X-ray Machine in the Food Warehouse.
Source: OIG, June 2024 (Red Box Added to Highlight the Dead Rodent)
