Concurrent Inspections of BOP Food Service Operations

Report Number: 25-062 | Posted Date: June 17, 2025 | Division: Evaluation & Inspections

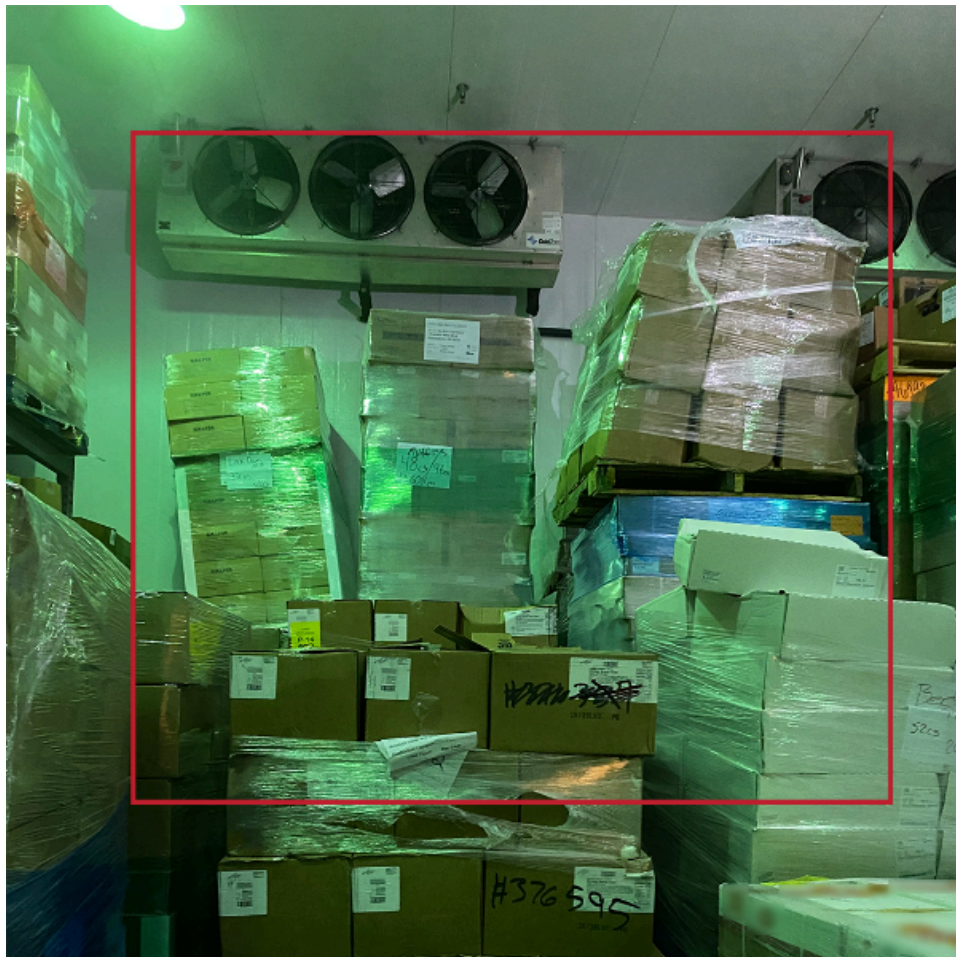
Within the warehouse freezer that was operational at the time of our inspection, pallets of food were precariously stacked, creating a serious safety hazard as food packages could fall on inmates and BOP employees working in the area. The BOP reported that this issue has been addressed and provided a photograph from May 2025 evincing that food is stacked safely in a warehouse freezer.

Boxes of Food Precariously Stacked, Leaning inside a Freezer.
